## **Yaesu FT-736R PSU repair**

Updated for DigiKey (North American) sources & data  
*I gratefully acknowledge OZ1DB and his original repair documentation  
and DL7VHF for his schematic diagrams*

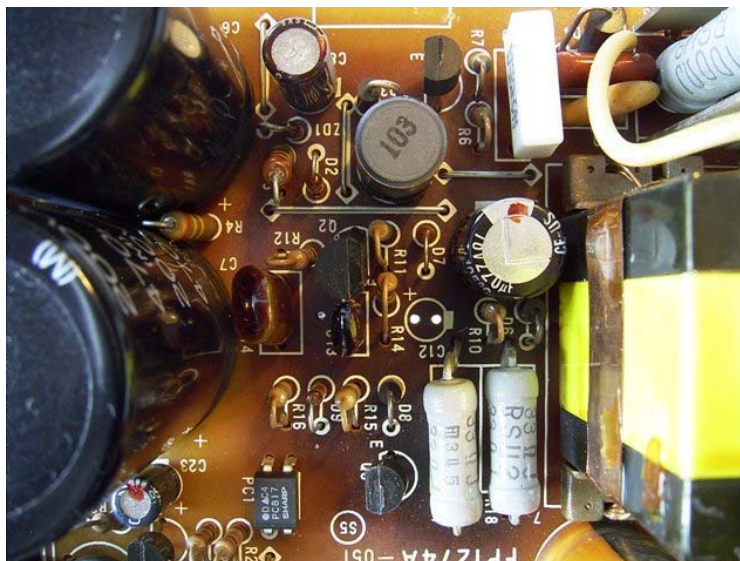
The board is usually discolored between the two 470μF/200V electrolytic capacitors and the transformer. The reason for this (and the short life of the capacitors) is two very hot 33ohm, 2W resistors (R17 and R18). See figure 1.

Fig 1. - Check C8, C9, C12 (C12 is removed here) and C22. They are likely out of spec.

- a. I suggest you replace at least C8, C9, C12 or preferably all electrolytic capacitors on the PSU PCB with +105 C versions, but not necessarily the rectifier filter's 470 uF/200 V big caps, if they seem OK and you can measure their value or even better, the ESR too.

- b. Replace R17 and R18 (optional) with a pair of 5W, 33ohm resistors (DigiKey p/n 45F33RE-ND). Install the new resistors on end, and do not trim the long lead...instead coil it so that it can dissipate some of the heat from the resistor (wrap it around a drill bit to coil it).

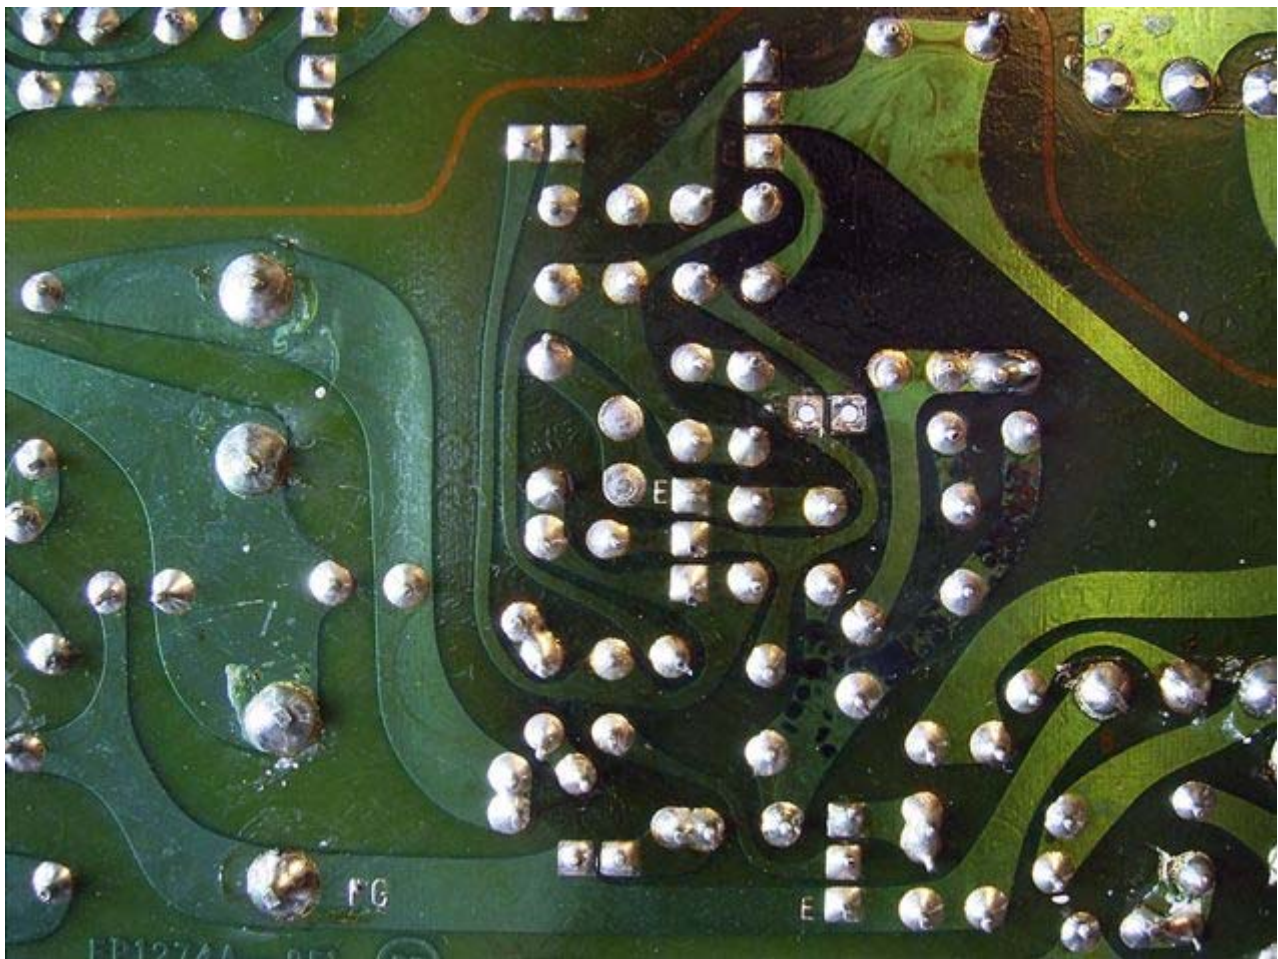
Fig 2. Thoroughly inspect the solder side of the board for cracked solder joints - the next picture shows several bad joints.

- c. Re-solder (with fresh solder and flux) all the cracked or “cold” solder connections on the PCB (especially around the transformer).
- d. Remove solder splashes (and possible solder bridges) with brush carefully.

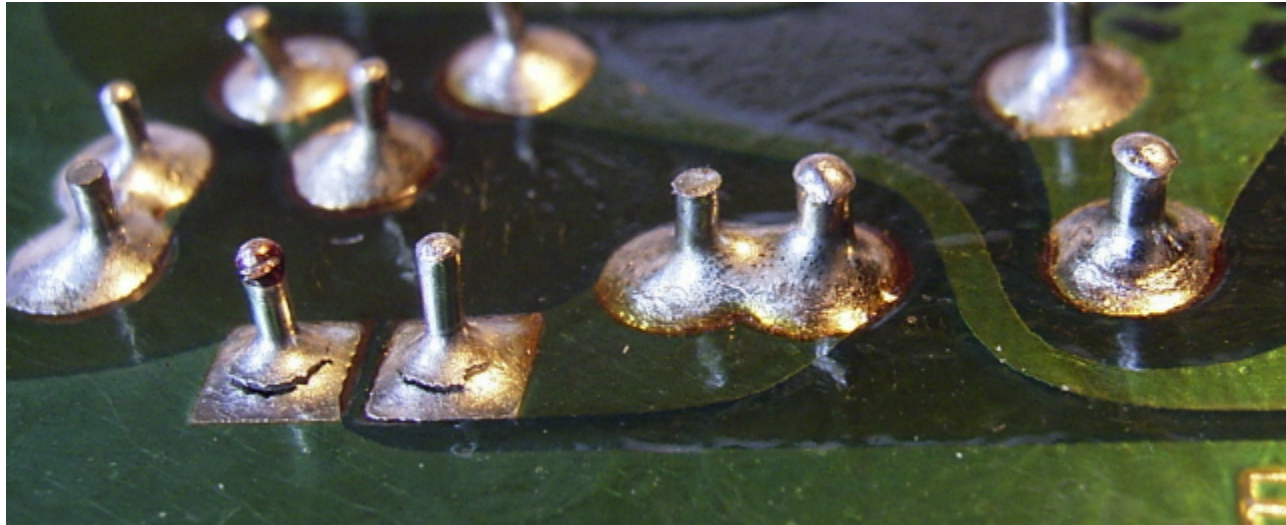
Fig 3. Close up photo showing cracked solder connections

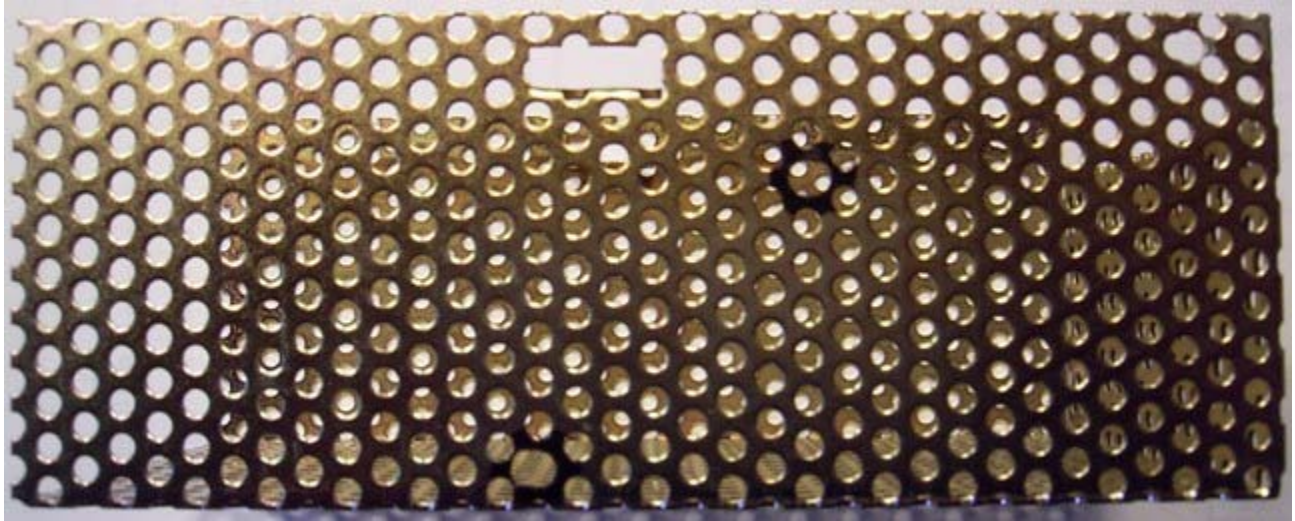
Fig 4. Modified cover with two oval shaped holes for the fan. These holes were enlarged up to 3.8 mm before filing them into an oval shape.

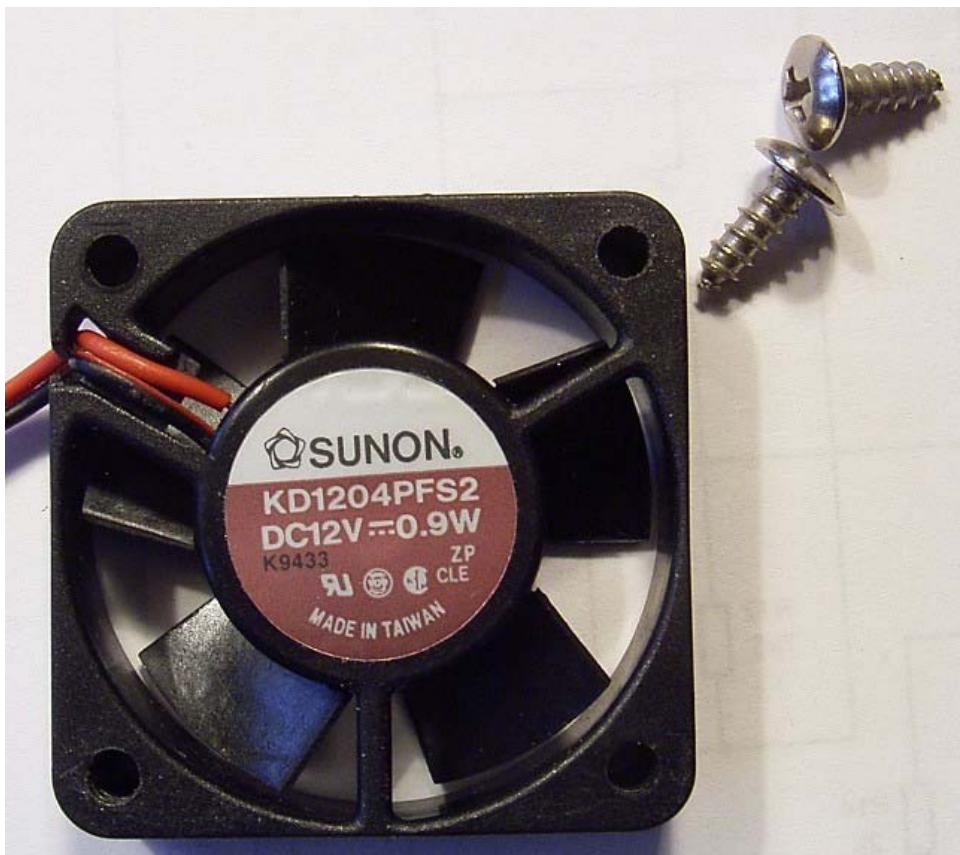
Fig 5. Fan with 2 x 3.5 mm screws

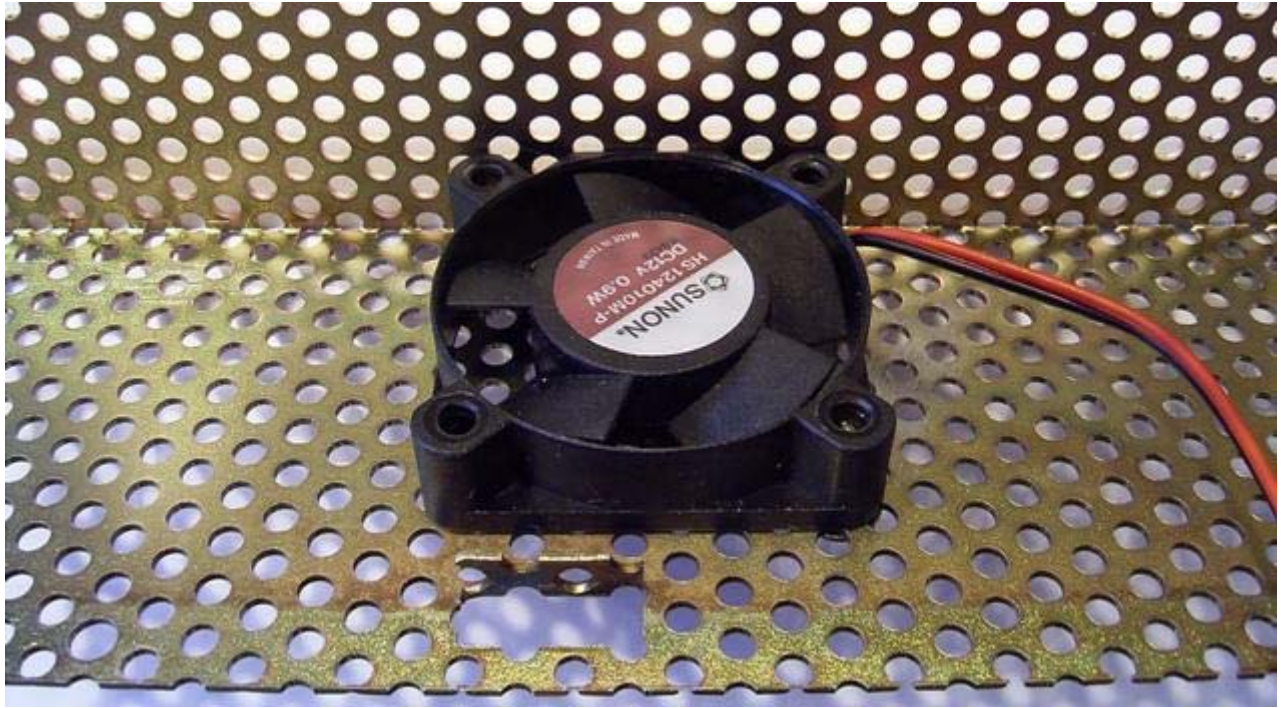
Fig 6. Fan at site, wires are cut 12 cm from fan

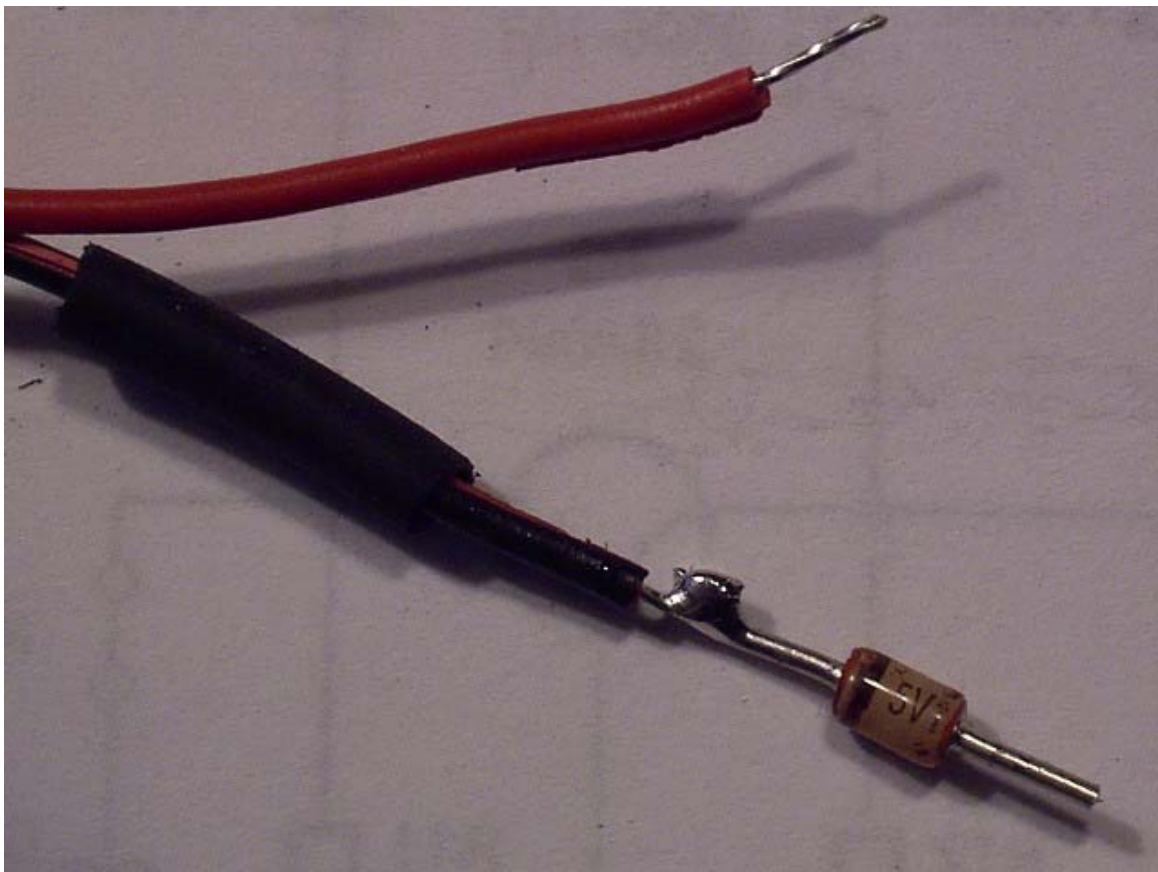
Fig 7. A 5V/1W zener diode plus a piece of shrink tube are added to the minus wire (the fan speed is reduced to improve lifetime and reduce noise)

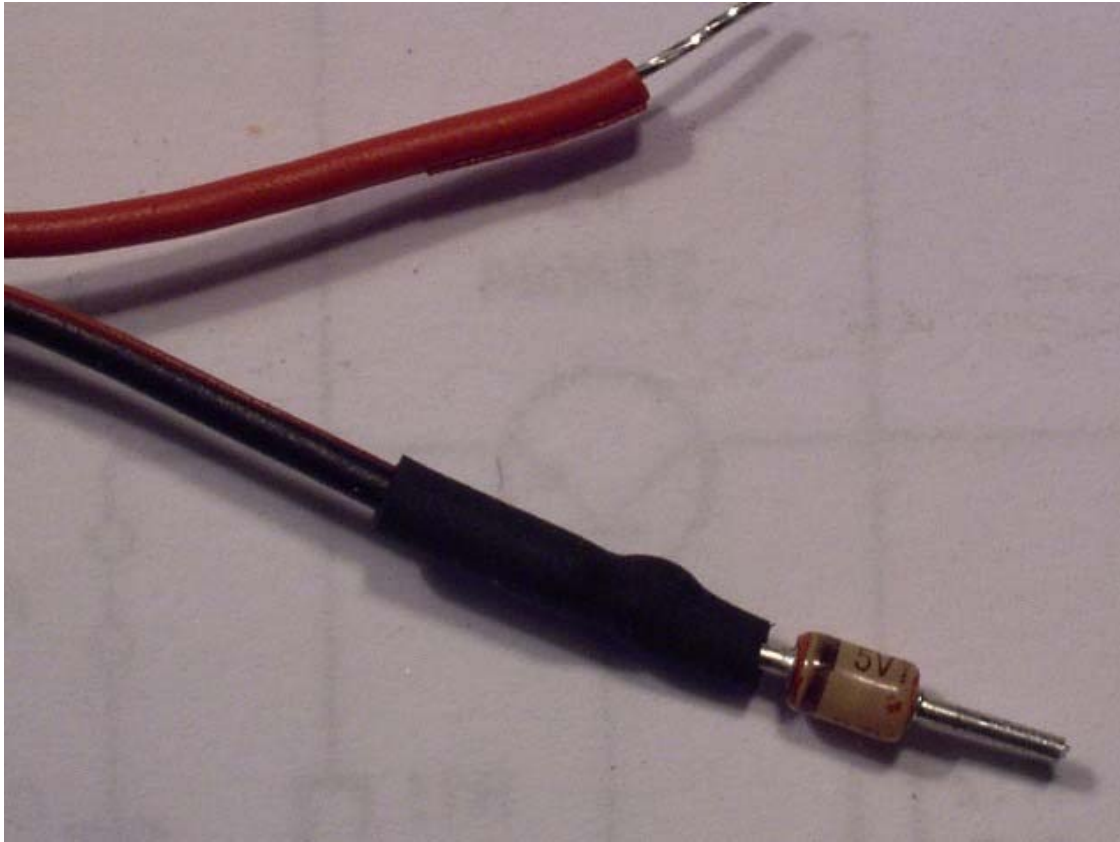
Fig 8. The wire and diode is ready to insert the PCB-holes and solder

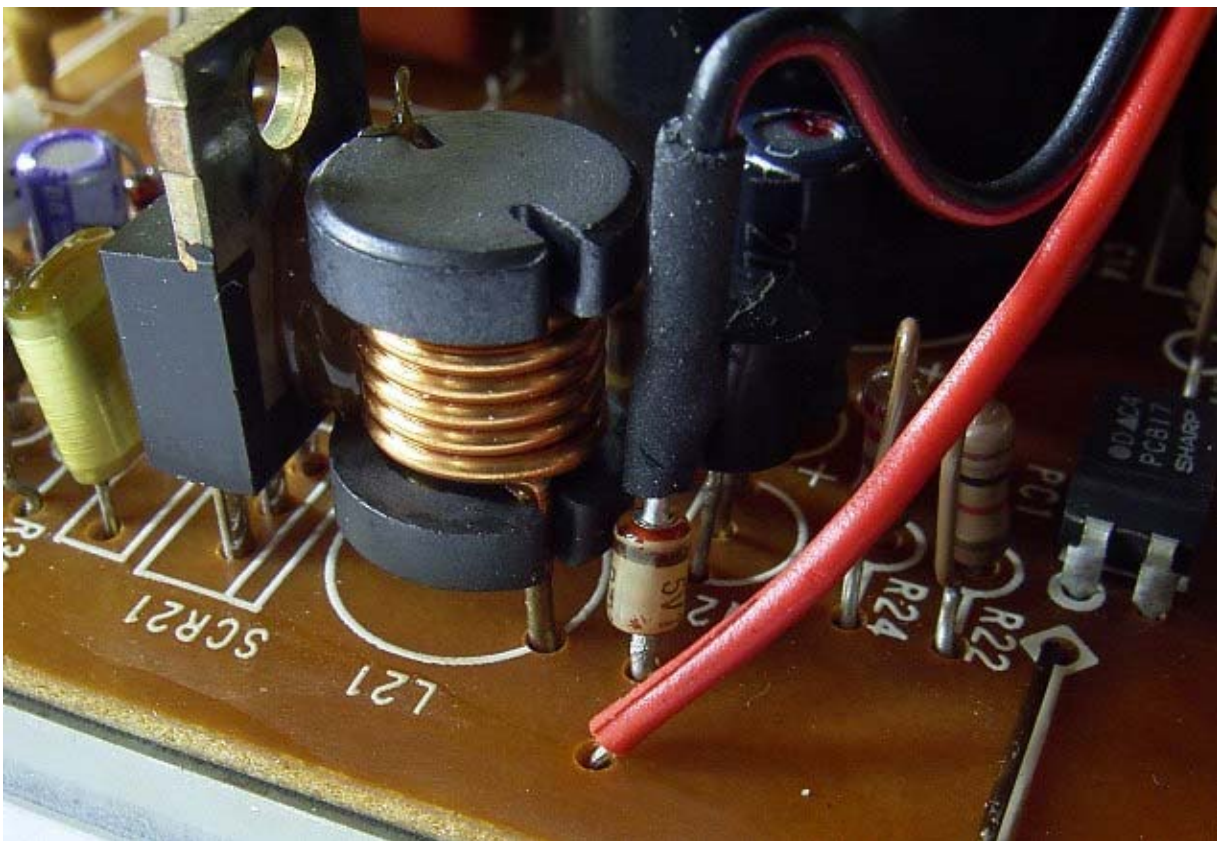
Fig 9. Notice where and how the wire and diode are inserted into the PCB

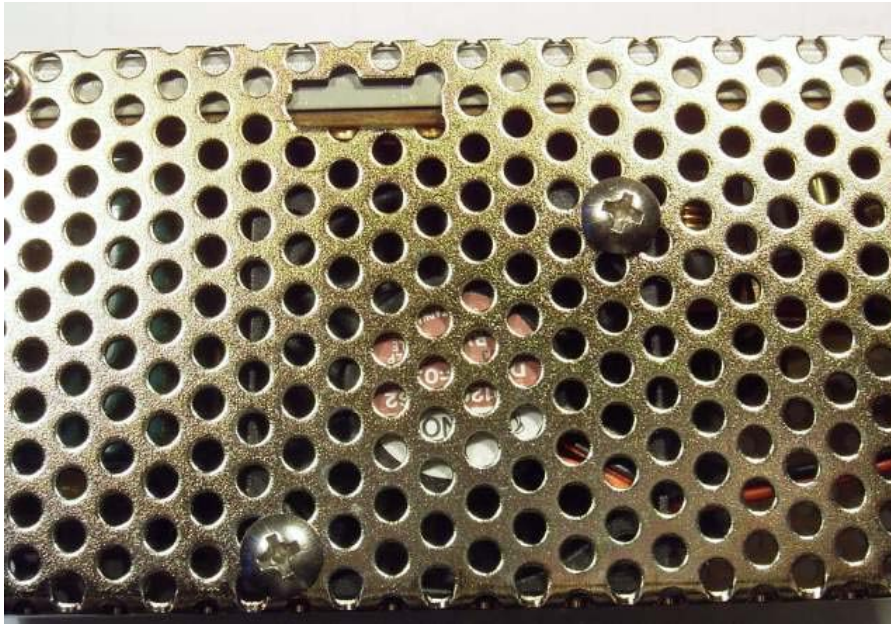
Fig 10. Showing the fan through the perforation

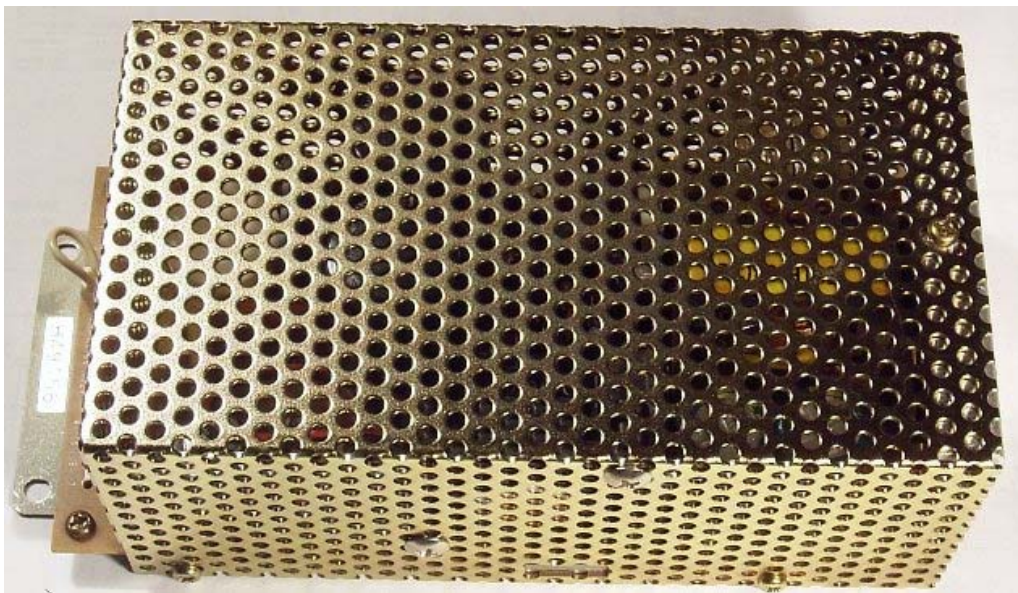
Fig 11. Completed power supply ready to install into FT-736R.

Be sure to roll and shake the unit to check for any loose parts inside. Remove any objects that do not belong there.
